ROYAL ARTILLERY QUAYS (RAQ)

SARK TOWER (E)

GRANARY MANSIONS (F)

## FIRE RISK APPRAISAL OF EXTERNAL WALL CONSTRUCTION

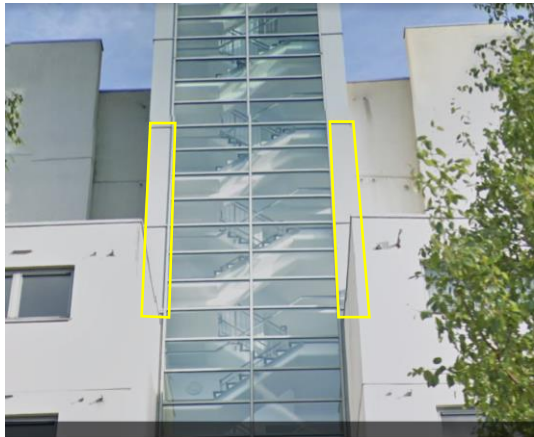
Figure 3 Extent of Corner Panel Replacement (Panel Type 3.1)

| <b>Block Ref.</b> | | <b>Sark Tower</b> | <b>Granary Mansions</b> |
| <b>Panels for Replacement</b> | | 5 <sup>th</sup> & 6 <sup>th</sup> Floor | 4 <sup>th</sup> & 5 <sup>th</sup> Floor |

| R6 | Wall Type 3 – Panel Type 3.1<br>(Aluminium Corner Infill Panels) | Both Blocks | <p>At Penthouses – No change.</p> <p>Small Single Stair Wings – No change.</p> <p>Tower Escape Stairs – As a minimum, replace the panels over a 2-storey height immediately above the southern roof terraces (See Figure 3) with replacement panels constructed with materials achieving a Class A2-s1,d0 (or better) in accordance with BS EN 13501-1.</p> |

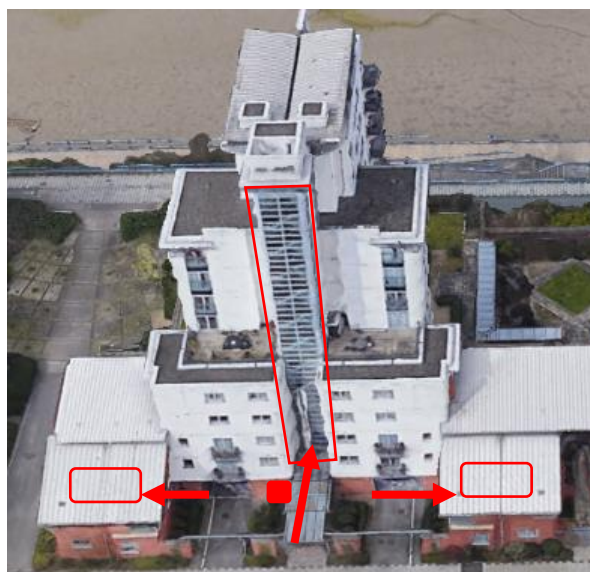
Figure D2 Typical Core Arrangement

Each of the blocks is served by a dry rising main that features landing valves on all above-ground floors of the central towers. The small single stairs, which feature separate entrances and common stairs (see Figure D2), do not feature dry mains but are limited to three storeys in height (<18m).

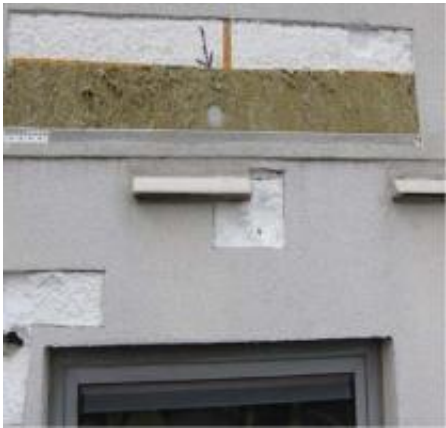
Figure E2 Wall Type 1 – EWI Systems

- a. **Fire Barrier Mechanical Fixing Spacing:** Fewer fixings than specified (specified maximum horizontal distance 400mm) and up to 1200mm observed on site.
- b. **Fire Barrier Mechanical Fixing Type:** Steel pin with plastic washer, rather than steel washers as specified.
- c. **Secondary Fixings:** Steel fire fixings were required at a rate of 1 per 1m<sup>2</sup> but not evidenced.
- d. **Render Coat Thickness:** Specified thickness 7.5mm (6mm basecoat & 1.5mm top). Observed typical thickness c.3mm-5mm.
- e. **Insulation & Fire Break Adhesive Application:** Dot and dab application technique adopted, rather than full bead as specified, resulting in small cavity between the system and its masonry substrate.

Deviations from the Weber specification are sporadic in nature, and due to the adoption of sampling to confirm wall build-ups, there may be areas of the wall type that deviate further from the specification.

| Typical Principal Elevation featuring EWI | Intrusive investigations reveal a fire break at a typical floor level. Plastic fixing washer visible. |

| Ref | Title | Location | Recommended Action |
|---|---|---|---|
| R1 | Wall Type 1: EWI System <sup>(4)</sup> | Both Blocks | Replace the EWI system with a system achieving a reaction to fire classification of Class A2-s1,d0 (or better) in accordance with BS EN 13501-1 and fire safety features in accordance with the latest statutory fire safety guidance. |

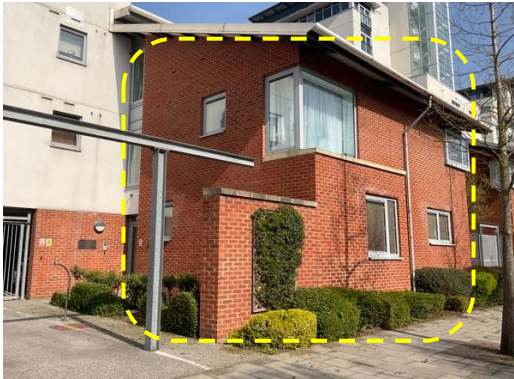
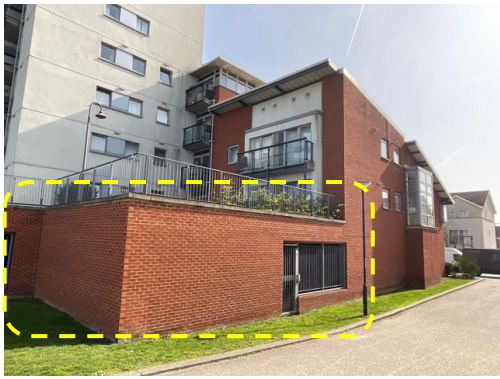
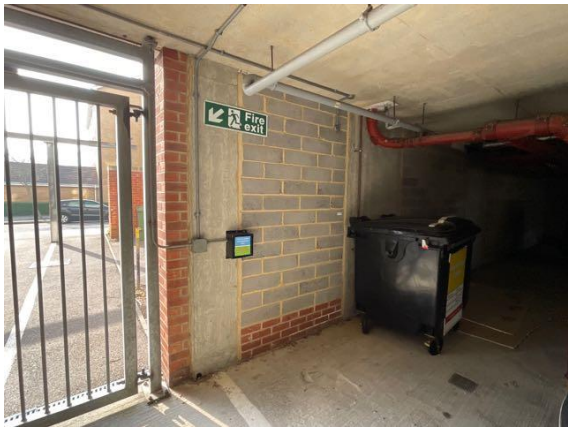
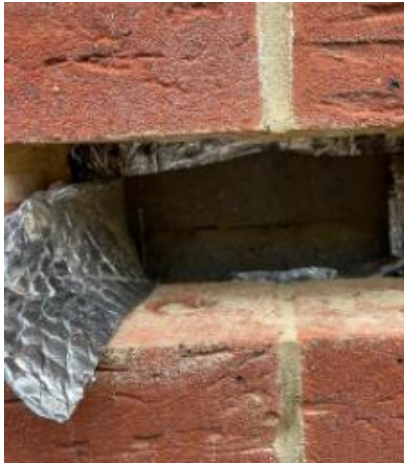
Figure E3 Wall Type 2 – Masonry Walls

| Masonry wall to flats | Masonry wall to ancillary accommodation |
| Masonry inner leaf visible from the car park | Airtec Insulation Layer, with inner leaf visible |

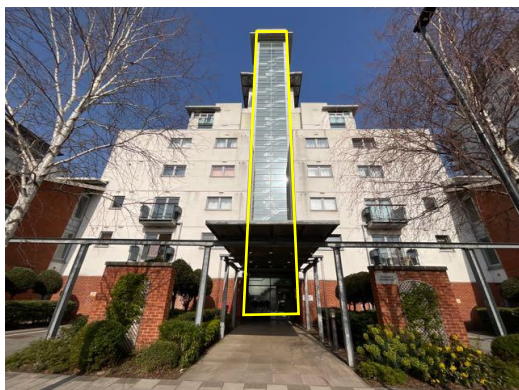
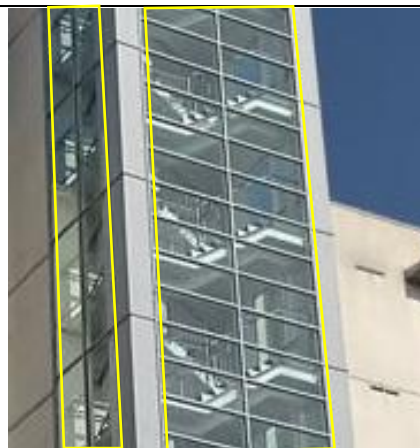
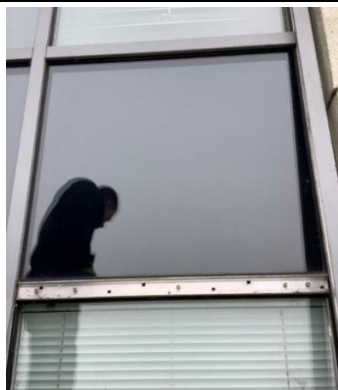
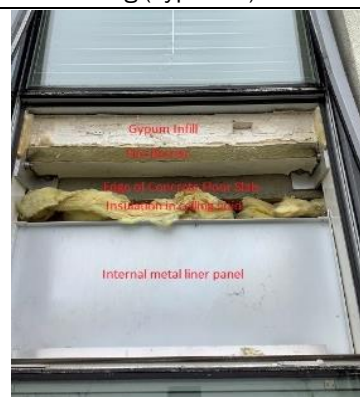
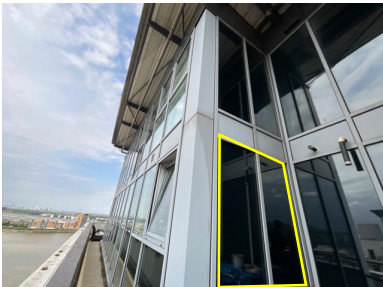
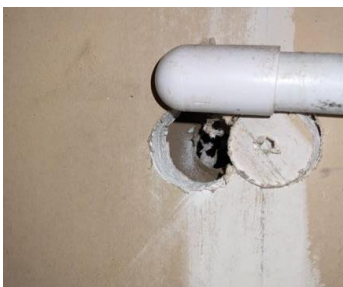
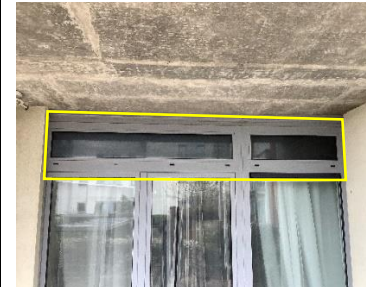
Figure E4 Wall Type 3 - Curtain Walling (Glazed Panels)

Vision Panels Stair & Common Corridor Curtain Walling (Type 1.0)

Opacified Glazed Spandrel (Type 2.1)

Exposed construction behind the glazed panel

| Example @ Penthouses | | Example Below Balcony Slabs |
| Opacified Glazed Infill Panel (Type 2.2) | | |

| Ref | Title | Location | Recommended Action |
|---|---|---|---|
| R4 | Wall Type 3 – Panel Type 2.1 (Opacified Glass Spandrel Panels) | Both Blocks | Replace the existing fire stopping with a proprietary fire stop between the concrete slab edge and the rear of the spandrel panel. The fire stop should be designed and installed to achieve a minimum fire resistance of 120min(EI). |

| | | | Replace the spandrel panel rigid board polymeric insulation with an insulation achieving Class A2-s1,d0 (or better) in accordance with BS EN 13501-1. |

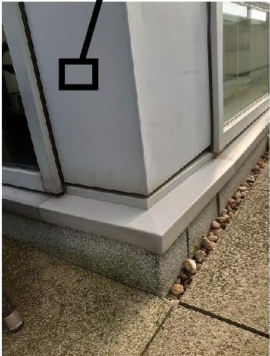
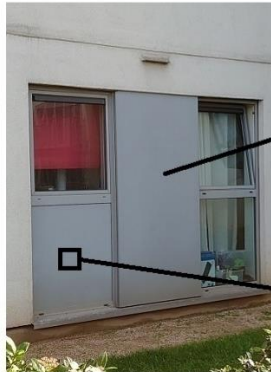
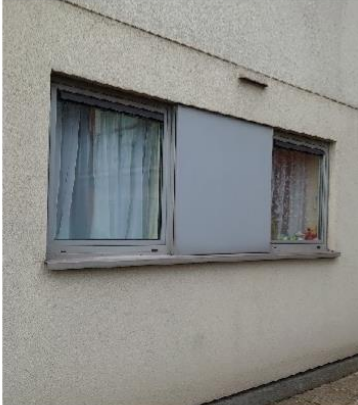
Figure E5 Wall Type 3 – Window Systems (Aluminium Panels)

| Panel Type 3.1 – Corner Panels | Panel Type 3.2 – Below Window Panel |
| Panel Type 3.3 – Infill Panel | Panel Type 3.4 – Spandrel (@Small single stair wings) |

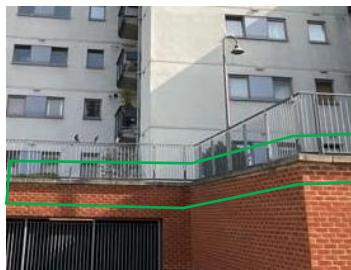
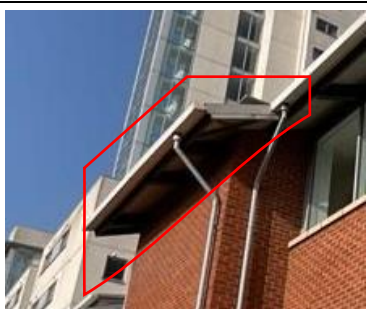
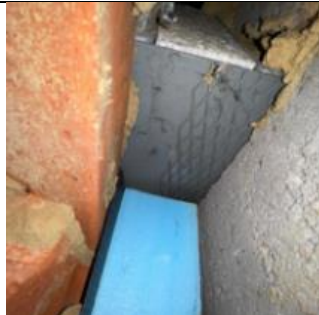
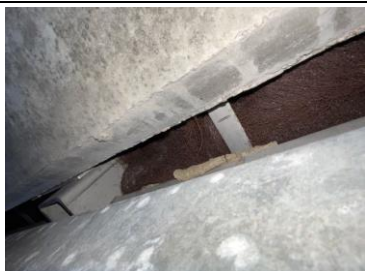
Figure E6 Illustration of Masonry Cavity Closure (WT2)

| Perimeter Capping with closer and aluminium flashing | Curtain Walling Termination with reconstituted stone (Closed) | Recon Stone Capping (Closed) |
| Eaves Termination ( <b>Open</b> ) | Typical Window Detail | Visible opening closure |
| Car Park Ventilation Opening Closure | Typical Air Brick to Roof Void | Typical Boiler Flue Penetrations |

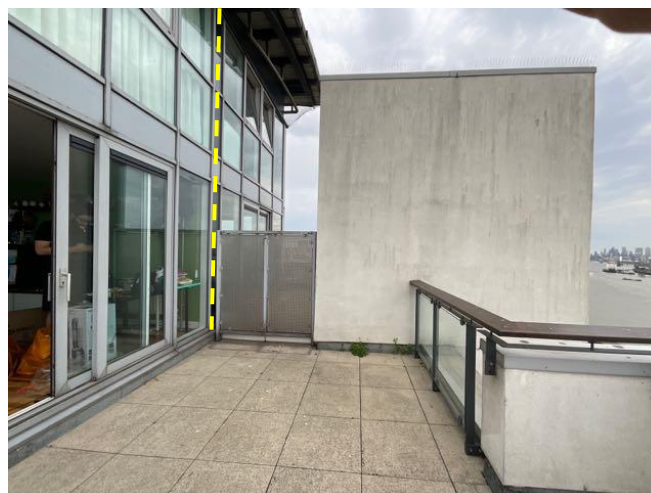
Figure E8 Example of Wall Type 3 (Panel Types 2.2 & 3.4) – Penthouse Party Wall Location

| Wall Type | Provision | Description |
|---|---|---|
| | Unknown | Panel Type 2.2 & 3.4 - Intrusive investigations provide no evidence of fire stopping at the party wall junctions between penthouse apartments. See Figure E13 (Image taken at Sark Tower) |

| R5 | Wall Type 3 – Panel Type 2.2<br>(Opacified Glass Infill Panels) | Both Blocks | <p>Penthouse (Party Wall Lines – See Figure 4) - Install proprietary fire stopping at the junction of the party wall and the rear of the remediated infill panels. The fire stop should be designed and installed to achieve a minimum fire resistance of 120min(EI).</p> <p>Replace the existing rigid board polymeric insulation with an insulation achieving Class A2-s1,d0 (or better) in accordance with BS EN 13501-1.</p> <p>Other Penthouse panels – No change.</p> <p>Below Balconies - No change.</p> |
| R9 | Wall Type 3 – Panel Type 3.4<br>(Aluminium Spandrel Panels) | Block E | <p>At Penthouses (Party Wall Lines – See Figure 4) - Install proprietary fire stopping at the junction of the party wall and the rear of the remediated spandrel panels. The fire stop should be designed and installed to achieve a minimum fire resistance of 120min(EI).</p> <p>Replace the existing rigid board polymeric insulation with an insulation achieving Class A2-s1,d0 (or better) in accordance with BS EN 13501-1.</p> <p>At Penthouses (Not on party wall line) – No change.</p> <p>Small Single Stair Wings - No change.</p> |

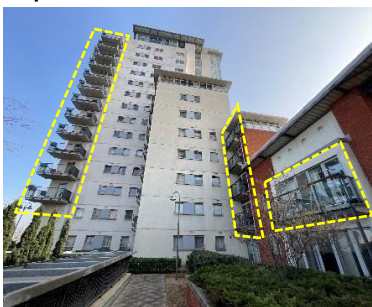
**Table E10 Balcony Construction**

| Type | Description | Locations | Design / Geometry | Observed Use |
|---|---|---|---|---|
| 1 | Projecting (Private) | All Elevations | Standard: c1.5m*1m<br>Corner: | Lightweight outdoor furniture and planting.<br>No bulk storage or BBQs observed. |
| | <b>Example:</b><br> | | <b>Notes:</b><br>Vertical stacking varies from a single balcony to a continuous run of 12 balconies. | |
| 2 | Juliet Balconies | South Elevations | c.1-1.5m width | None |
